10FTM03

# **A Novel Approach to the Refurbishment of Wind Turbine Gears**

By M. Michaud, REM Surface  
Engineering, G.J. Sroka and  
R.E. Benson, REM Research  
Group

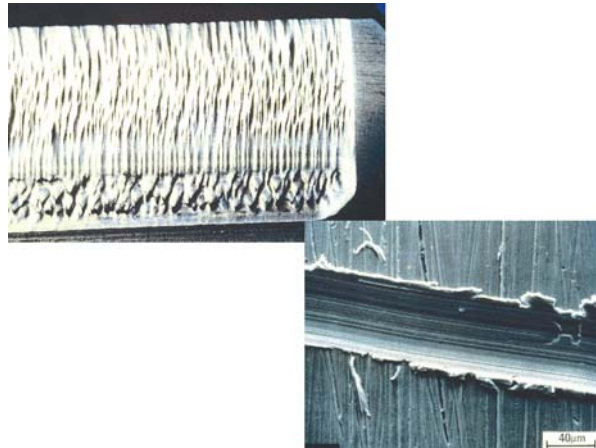
Figure 1b. Heavy abrasive wear on gear flank and a SEM image of trail left by an abrading particle [4]
