Expectations for a chemically accelerated superfinishing process

► Second in a series

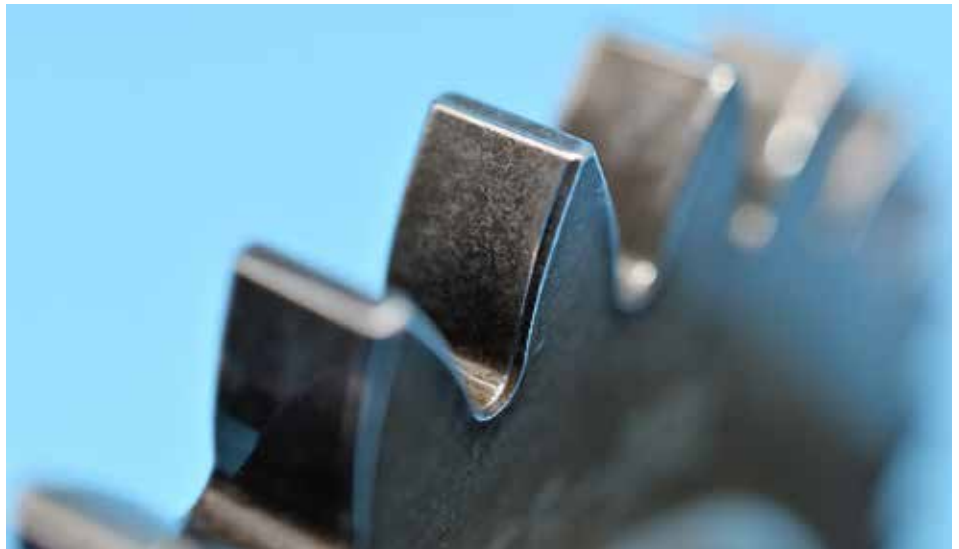
The first step of the investigation was to perform visual inspections, verify the surface roughness, and photograph the tooth flanks in the as-received condition with the heavy conversion coating intact. The tooth flanks appeared smooth, uniform, and black to the eye, just as GRI had described. See Figure 1 for a macro image of this condition.

Figure 1: As received visual inspection image.

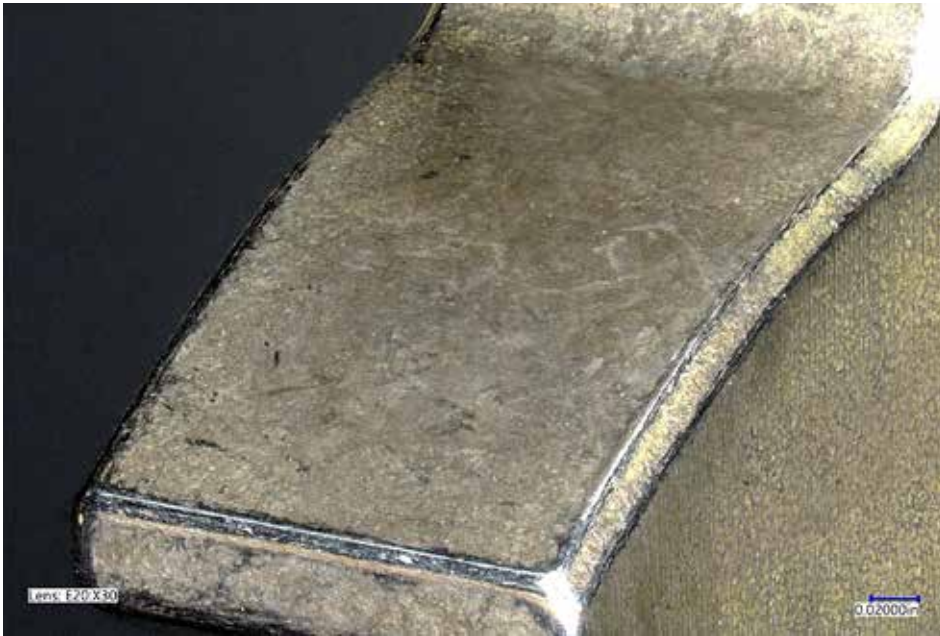
to document the as-received condition. These, like the initial visual inspection, indicated the surface was nicely finished, but covered with the conversion coating. In the 30X magnification image shown in Figure 2, it is possible to see the light swirl/scratch patterns in the conversion coating created by the media during the refinement/stock removal process.

Figure 2: As received image at 30x which appears to be a nicely superfinished tooth flank.

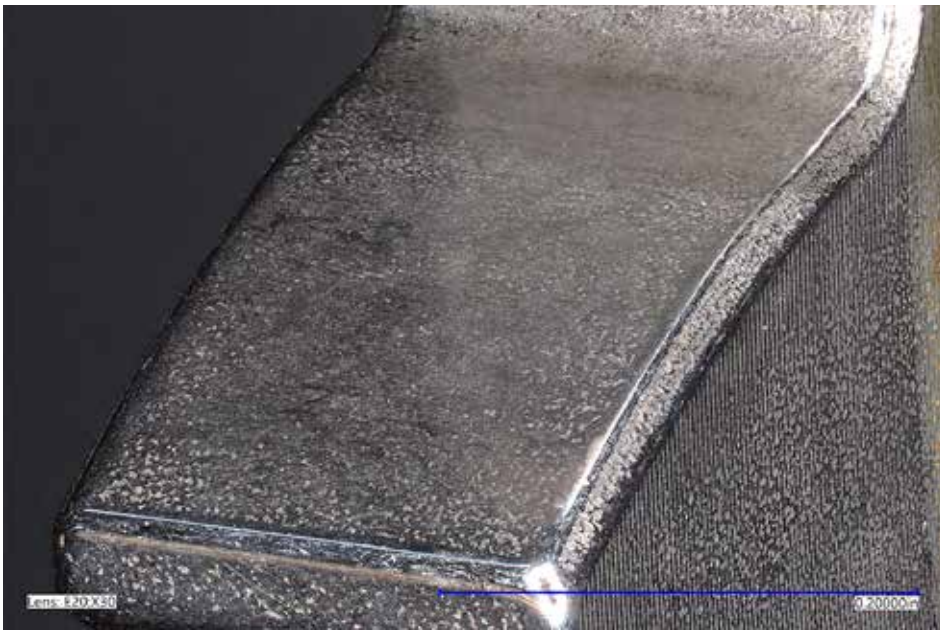
Figure 3: 30X image of tooth flank revealing hidden shot peen dimples after burnish step to remove the conversion coating.

in the clean, reflective surface appearance most associated with an isotropically superfinished part. To our surprise, the surface that looked so nice when covered with the black conversion coating revealed a very different condition once cleaned. The tooth surface that appeared so smooth and uniform was anything but smooth and uniform. It became very clear that the conversion coating was masking the true surface that still exhibited a substantial amount of the shot-peen texture. The Keyence image in Figure 3 taken again at 30x clearly shows not only that the peening dimples remain, but that the finishing process did not remove stock uniformly across the tooth flank. It appears that an inappropriately sized media may have been used for processing that accessed the center of the tooth face more readily than the addendum, dedendum, and root. This is a common issue when isotropically superfinishing gears with tight pitch teeth if the process is improperly designed. Special media mixtures must be tailored to generate a uniform finish on these types of gears. The image also indicates that the surface roughness may not be as low in the areas outside the tooth flank center.
