# Corrosion and wear resistance of materials processed by beam-based AM technologies

A technical session at the World PM2022 Congress & Exhibition, organised by the European Powder Metallurgy Association (EPMA) and held in Lyon, France, October 9-13, 2022, focused on the corrosion and wear resistance of materials processed using beam-based Additive Manufacturing. This session comprised three papers which looked at ways to improve these properties – both particular pain points for AM's wider adoption – by way of chemical-mechanical surface polishing, adjusted laser power, and the development of new, wear-resistant alloys for AM. Dr David Whittaker reviews the presented papers.

## Chemical-mechanical surface polishing to improve mechanical performance and corrosion resistance

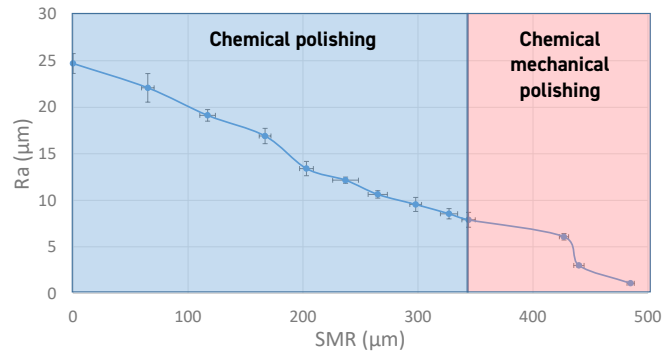
Fig. 3 Microscope images at 100 X magnification (a and b) with their 3D representations (c and d) of the surface of PBF-EB Ti-6Al-4V as-built tensile specimens, and the final surface after surface finishing (b and d). Average surface roughness ( $R_a$ ) progression per surface material removal through the surface finishing operation (bottom). The blue area on the plot shows the CP progression and the red area shows the CMP progression [1]

Fig. 3 shows the surface texture optimisation progression for PBF-EB Ti-6Al-4V specimens through the surface finishing operations. The as-built components showed typical surface texture features ( $R_a = 28 +$

1  $\mu\text{m}$ ) that were eliminated through the CP process by removing 350  $\mu\text{m}$  from the surface. The CP process reached a plateau and no significant change was observed upon further processing. At that point, the specimens were processed by CMP to achieve the required planarisation to target the required  $R_a$ . For the HCF (high-cycle fatigue) specimens built with contour and without contour, the  $R_a$  target was below 0.1  $\mu\text{m}$  and

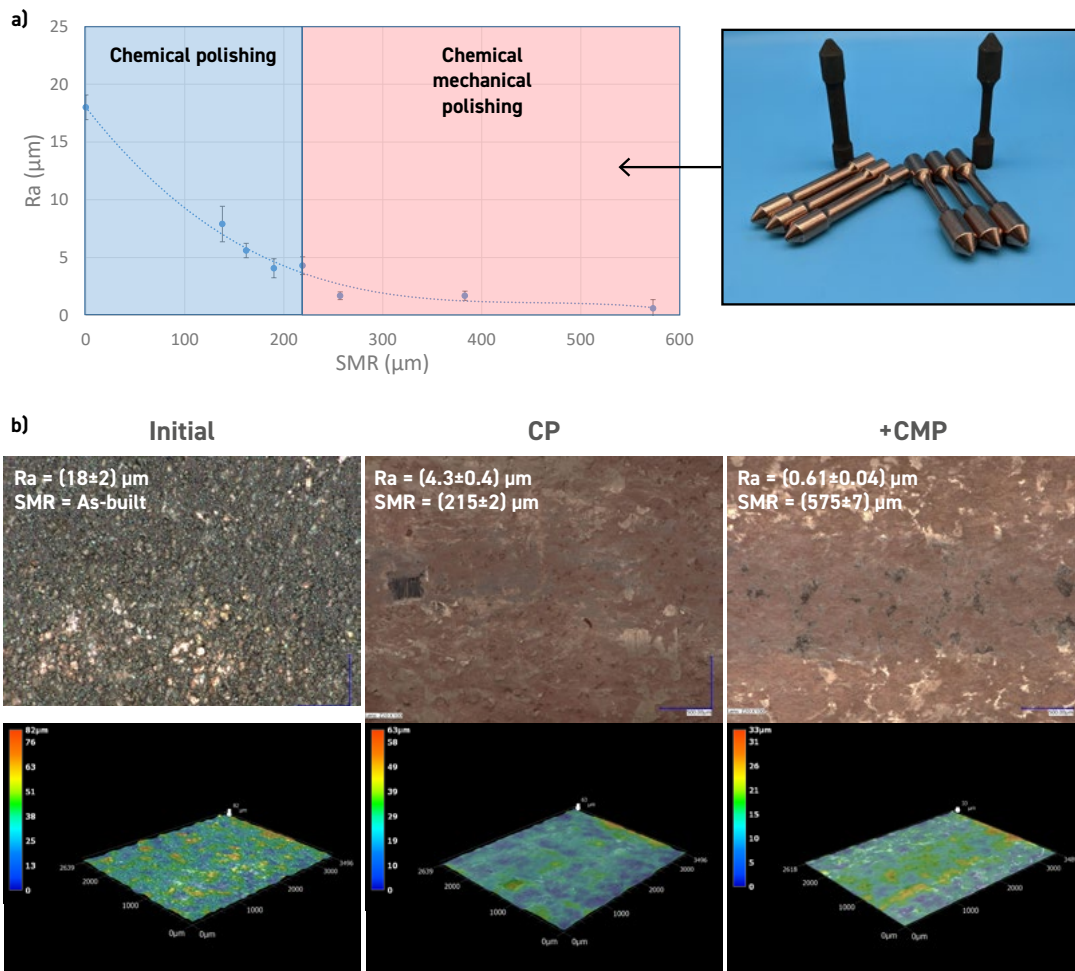
Fig. 4 Average surface roughness ( $R_a$ ) reduction per surface material removal through the surface finishing operation of PBF-LB GRCo-42, first CP followed by CMP (a). The blue area on the plot shows the CP progression, and the red area shows the CMP progression [1]

The second case study focused on PBF-LB GRCo-42 (Cu-4%Cr-2%Nb). GRCo-42 is a high-strength, dispersion-strengthened copper alloy with excellent conductivity, currently used in liquid rocket engines by NASA and other commercial space companies. Fig. 4 shows the surface texture progression for typical non-HIPed specimens of this alloy through the surface finishing operations. The as-built components show surface texture features overtaken by the partially sintered/melted powder on the surface, with  $R_a = (18 + 2)$

$\mu\text{m}$ . The initial surface texture improved remarkably through the CP process; in this specific example, by removing around 200  $\mu\text{m}$  from the surface, a  $R_a$  reduction of up to 78% was achieved; followed by the CMP process, reaching the lower possible  $R_a$ , where values under 0.6  $\mu\text{m}$  were achieved (Fig. 4).

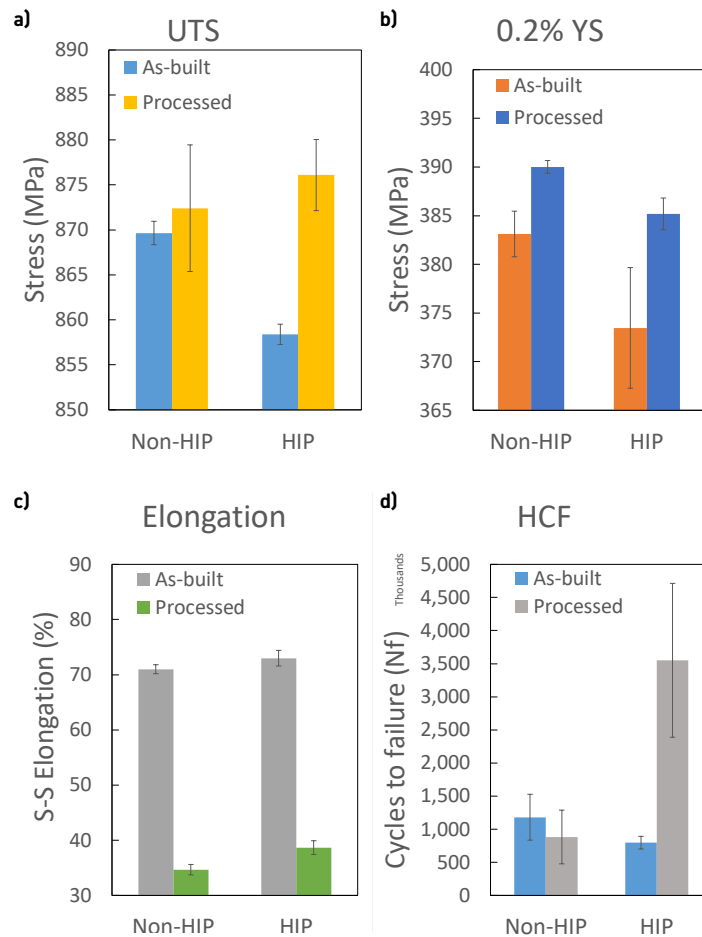
Fig. 5 Tensile strength (a), 0.2% yield strength (b), elongation (c), and uniaxial tensile high-cycle fatigue (Load at 434 MPa, room temperature,  $R = 0.1$ , and 60 Hz) of PBF-LB IN625 specimens before and after surface finishing and HIPing [1]

Fig. 5 shows the results of mechanical testing experiments performed on PBF-LB IN625 specimens. The tensile and yield strengths of the specimens were significantly reduced upon HIPing. Nonetheless, the surface finishing process increased these for both non-HIPed and HIPed samples and, in the case of the HIPed samples, the strength lost on HIPing was recovered. However, upon surface finishing, a significant decrease in elongation was observed. The observed effects on the tensile properties can also be associated with the residual compressive stress imparted to the material upon surface finishing. On the other hand, the effects of HIPing and surface finishing on fatigue properties were extremely significant, showcasing the importance of combining surface finishing and HIPing. Surface finished non-HIPed samples did not show a significant improvement in fatigue. The same was the case for HIP samples with no surface finishing.
